Manhole Inspection Summary

Manhole # S19II_027MH

Insp Date: **3/12/09 1:24 PM**

Location Address: **1821 NORTH-WESTWOOD**

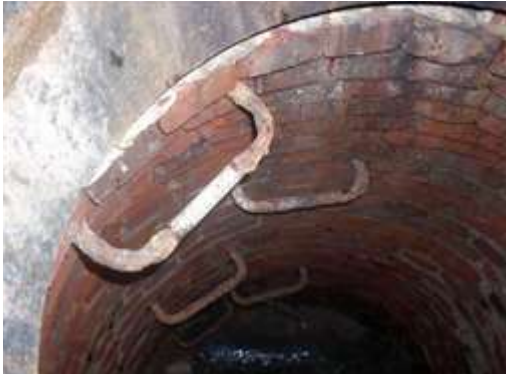
Defect 2

Count: **5** Missing: **0** ☒ **Corroded**

CORRODED STEPS

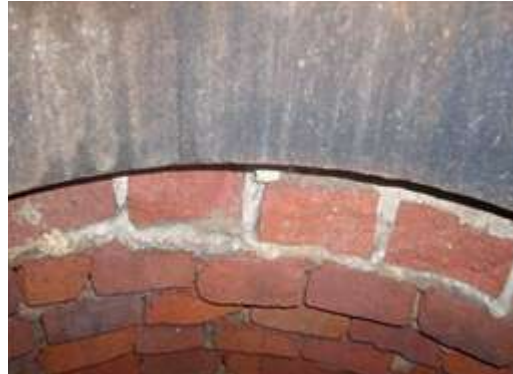
Defect 1

Condition: ☐ Sound ☐ Cracked ☐ Root Intrusion ☐ Loose Brick ☒ **Deteriorated**

DETERIORATION OF CHIMNEY

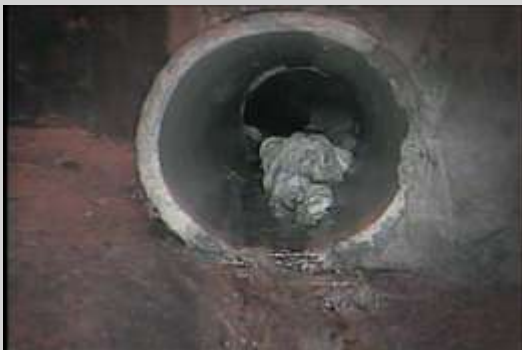
8 O'Clock Inflow

Deposits: ☐ None ☐ Mud ☐ Sludge ☒ **Debris** ☐ Grease

Silt Depth: **1** (in.) Deposits Extent: **Light**
